# Get Ready, Set, Go!.... STOP!!!

## The Challenges with a Simple Rail Bridge Coating Project

Dudley J. Primeaux II, PCS, CCI  
Primeaux Associates LLC

2019 PDA Conference  
October 17 – 18, 2019  
Hilton Orange County/Costa Mesa

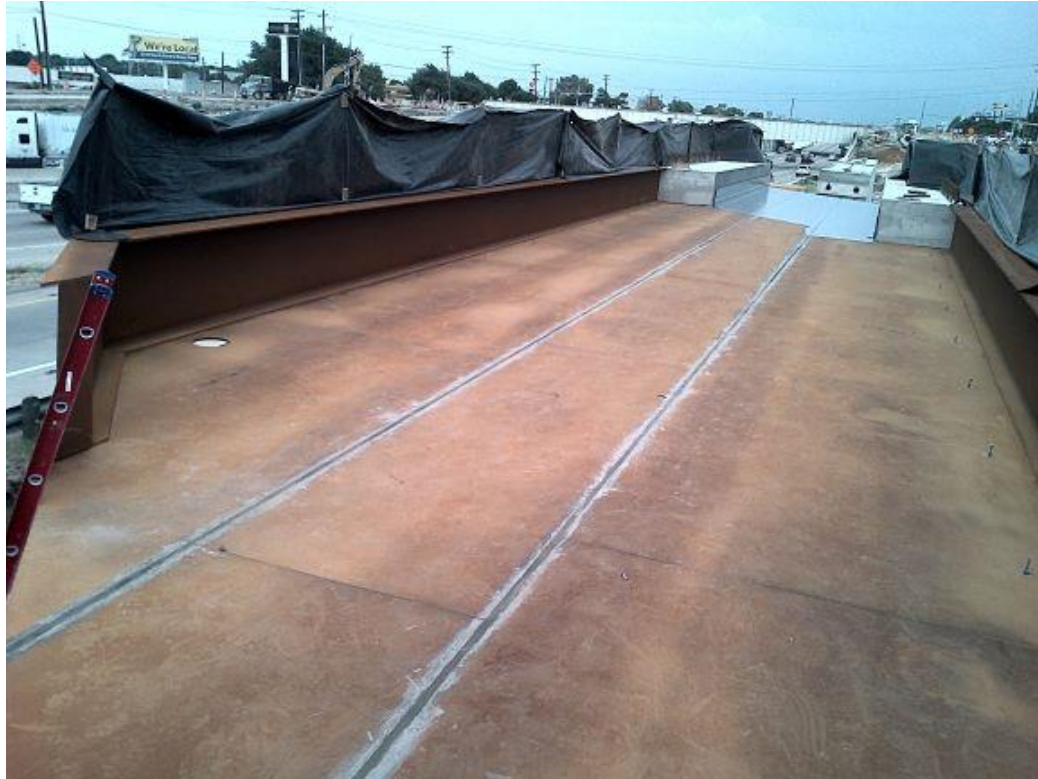
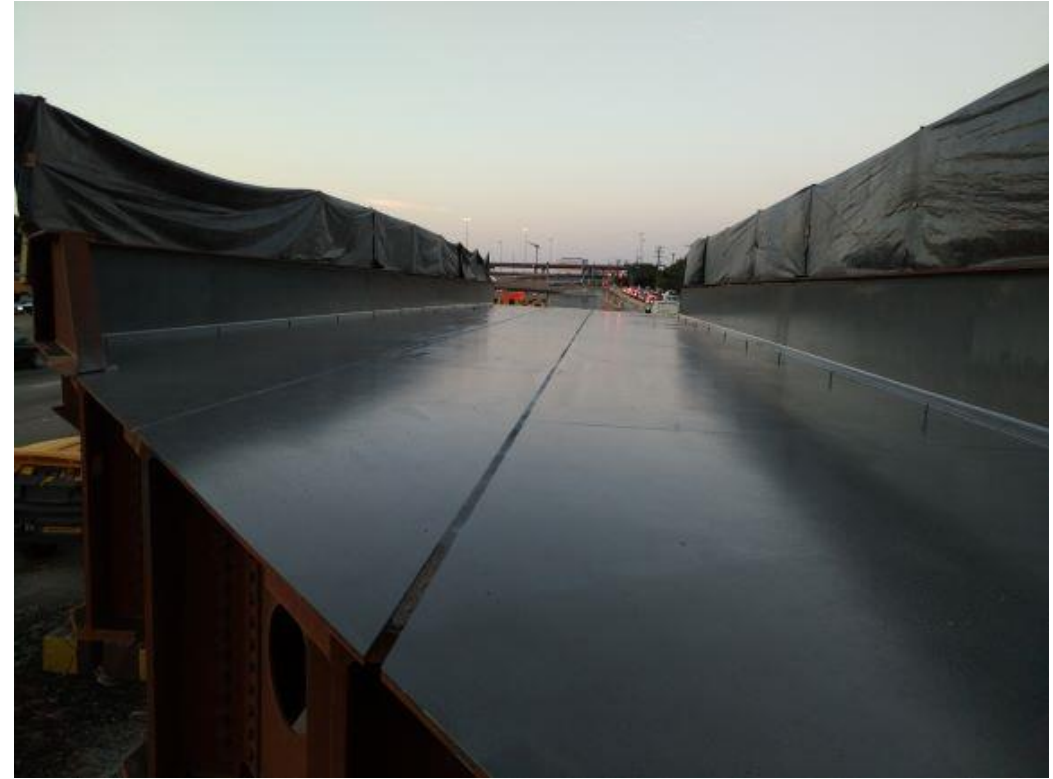
# First Mobilization

- First of August 2018
- One day preparing spray equipment for work
- Abrasive blasting for 2 days, < half deck done... Why????
  - Spec'ed SSPC-SP 5 ??? Weathering steel???? Adjusted to SSPC-SP 10
- Applied to “South-bound” bridge deck
  - Achieved min DFT requirements
  - Achieved min Adhesion requirements
- Application took 1.5 hours, done for this mobilization
  - Does not include waiting / standby time, that was all day (Murphy)....

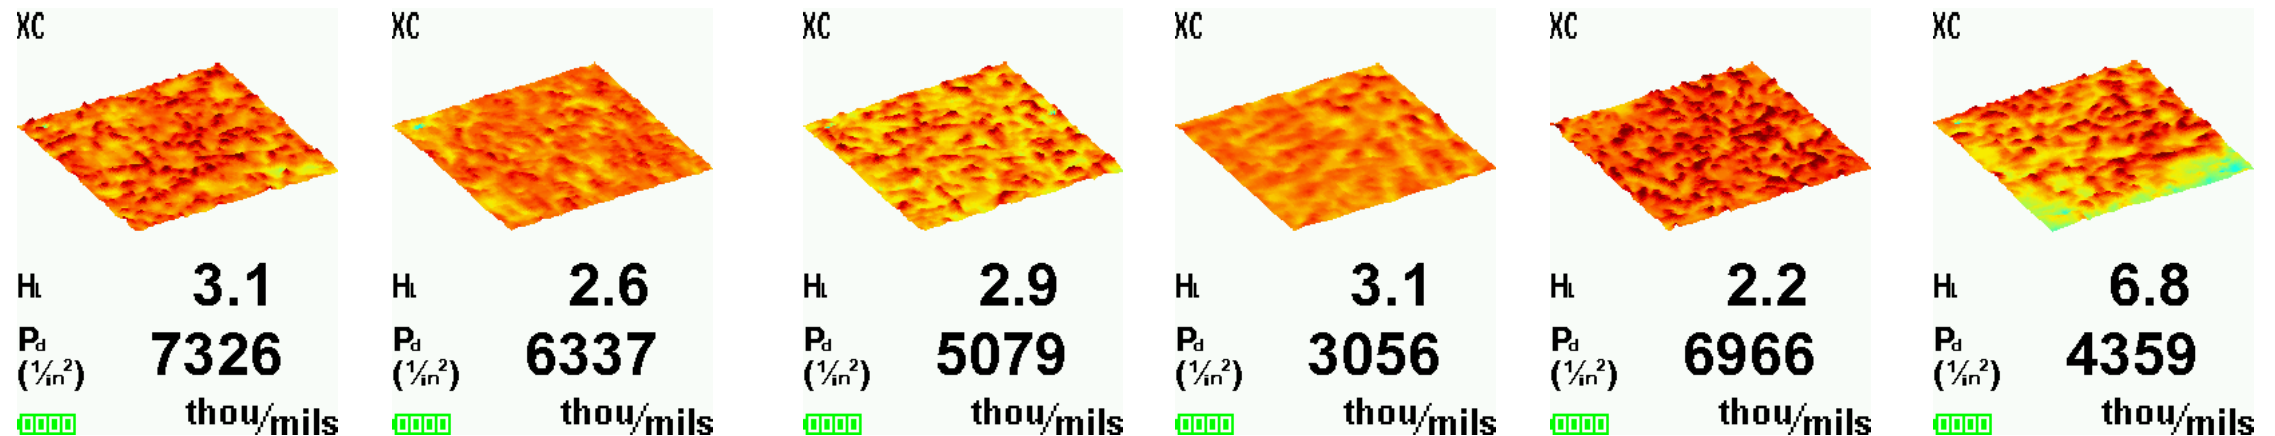
# Surface Profile Measurements

- **ASTM D 4417 / SSPC-PA 17 / NACE RP 0287-2016**
- DeFelsko PosiTector ADV Body, s/n 731896 / PosiTector RTR-P, s/n 247342, Testex Press-O-Film HT X-course

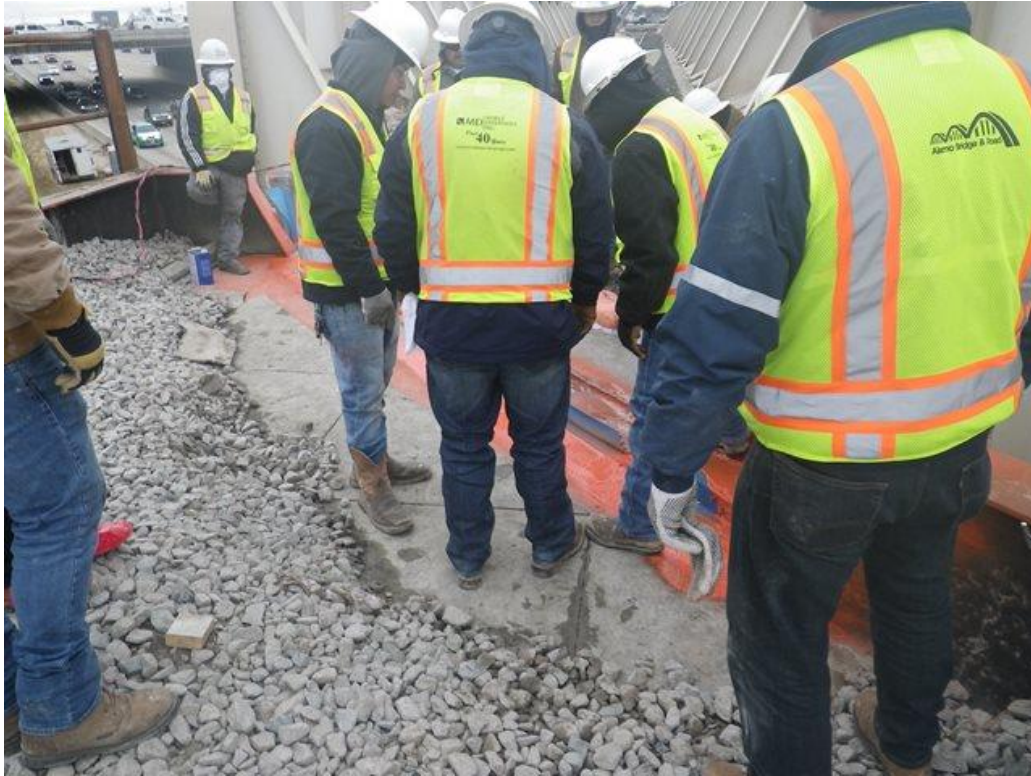
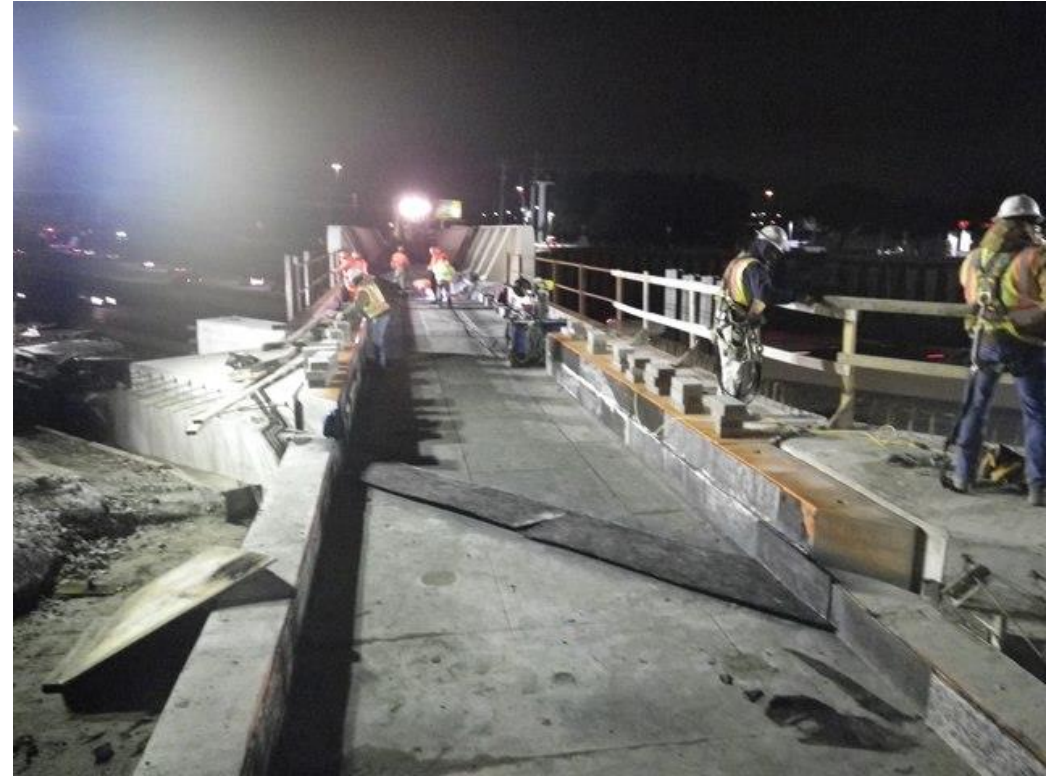
# Fifth Mobilization

- Uncle Murphy's last visit of the project....
- Design drawings did not match to placed bridge section
- Fabricate some special plates, wait on welders.....
- Dallas Cowboys playoff game on.....
- Lot's of tension.....
- But, got it done, covered and ballast, rails set and train traffic resumed....

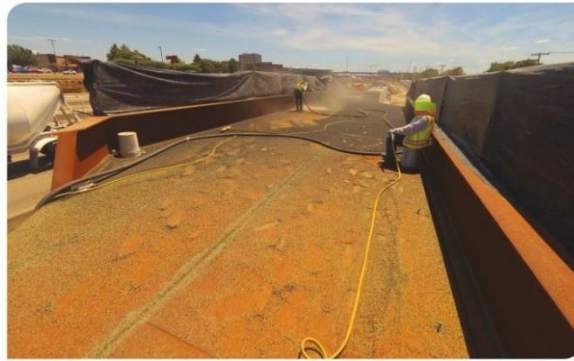
A crew from Mobile Enterprises Inc. was surprised to see weathered steel on two new spans for a rail overpass project in Plano, Texas. Sandblasting to prepare took much longer than expected. Photo courtesy of Mobile Enterprises, Inc.

Despite MEI's objection, the coating manufacturer instructed the crew to blast the steel to achieve NACE No. 2/SSPC-SP 10, "Near-White Metal Blast Cleaning." The blasters wore blast hoods with supplied air, while the crew members feeding the pot below wore respirators.

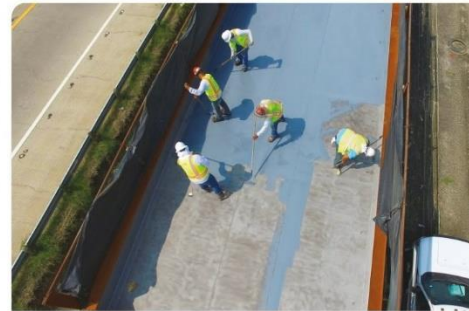
To hold the blast, the crew immediately applied a thin layer of Bridge Preservation's Multi-Use Primer FAST using squeegees and rollers. Photo courtesy of Mobile Enterprises, Inc.

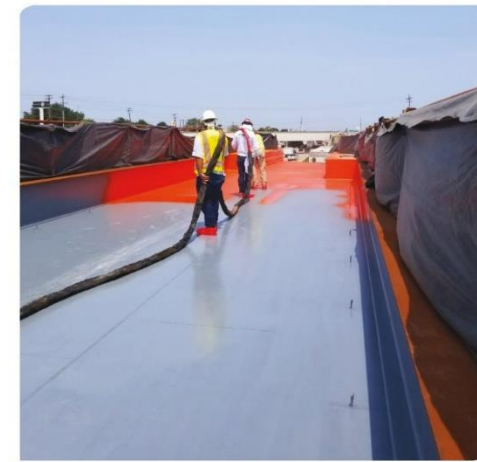
The Bridge Deck Membrane, protective polyurea was applied to an average of 120 mils (3,048 µm). Photo courtesy of Mobile Enterprises, Inc.

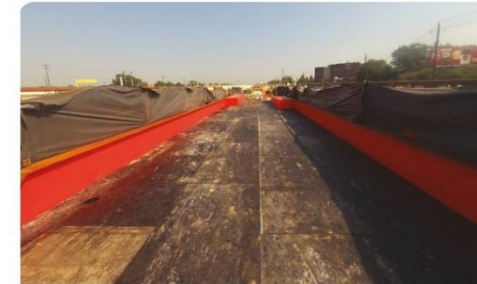
The polyurea needed to be protected before rocks and rail were installed on top. The crew used 1/2-in (1 cm) asphaltic board on the vertical and horizontal surfaces. Photo courtesy of Mobile Enterprises, Inc.
